## 4.0 FORMER AND CURRENT USES

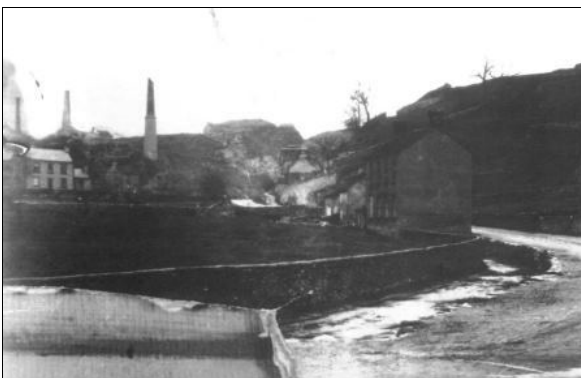
*P4.1 Chimneys on The Hills, used as flues from the smelt works*

derived from the mining operations carried on within it, and lead smelting works". Similarly White's Directory (1862) also confirms that mining and lead smelting were the major occupations. However, the lead industry significantly declined in the area from the middle of the nineteenth century and the Bradwell Slag Works, listed in White's Directory of 1862, closed in the 1860s. The 1880 First Edition Ordnance Survey map (Fig. 11) shows a 'Chimney', just to the west side of the garden to No. 1 Lyndhurst on The Hills, and a cluster of buildings to the west of this are thought to be the ruins of the Slag Works (Barnatt, 2007). The smelting hearths and associated buildings were demolished in the late nineteenth century and no chimney is marked on the 1898 Second Edition Ordnance Survey map (Fig. 12). Parts of the flues still survive (Barnatt, 2007).

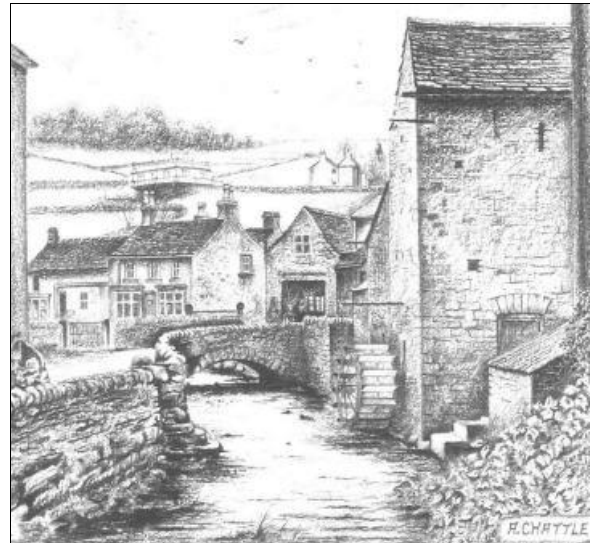
**P4.9** *Waterwheel to drive the generator for ice-cream manufacture*

**4.29** Bradwell's Dairy Ice-Cream was invented in 1899 by Hannah Bradwell. The ice-cream is still sold from the ice-cream parlour, on the corner of Bridge Street, where it was first made. The large barn-like building immediately to the rear of the former Wesleyan Sunday School on Bridge Street, was used for the manufacture of the ice-cream: a water-powered generator was in use from the 1930s-40s. A million litres of ice-

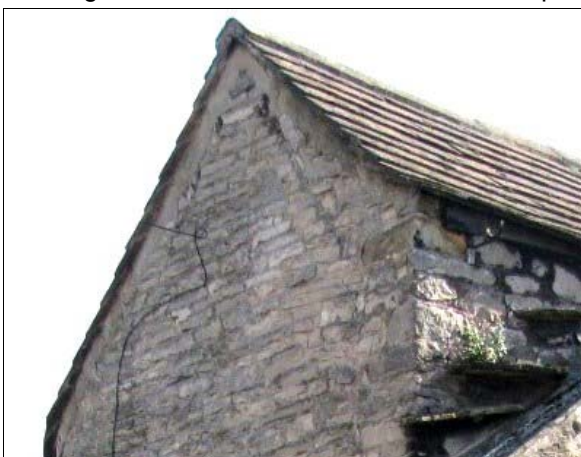
*P5.3 Evidence of an earlier, more steeply pitched roof to Bradwell’s Ice-Cream Shop*

**5.10** Medieval buildings in the village would have been timber-framed, and before the middle of the eighteenth century many of the humbler cottages would have had thatched roofs. No thatch remains and there is no surviving evidence of timber-framing within the Conservation Area. Thatched roofs would have been steeper than stone-clad roofs, however, and a few buildings show evidence of earlier steeper pitches, perhaps suggesting thatch, such as the gable end of Bradwell’s Ice-Cream shop.

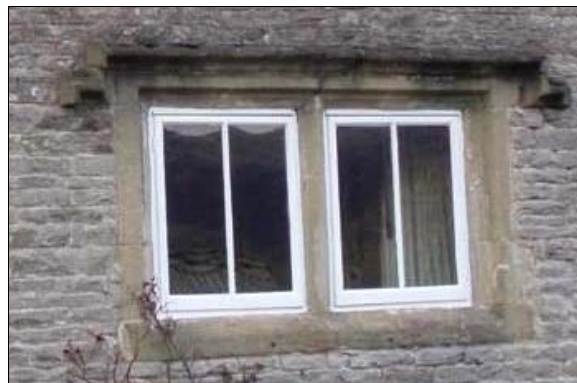
*P5.4 C17th double-chamfered, mullioned window at Smalldale Hall*

century windows were mullioned with chamfers, sometimes double-chamfered, and the openings had a horizontal emphasis, with small casements in rows. Eighteenth century windows tended to have mullioned windows with square-cut faces externally. The sills of both seventeenth and eighteenth century windows were flush with the face of the wall. Nineteenth century windows generally had larger sash openings with a vertical emphasis, with sills projecting beyond the face of the wall and often only a lintel and sill, rather than a full surround.

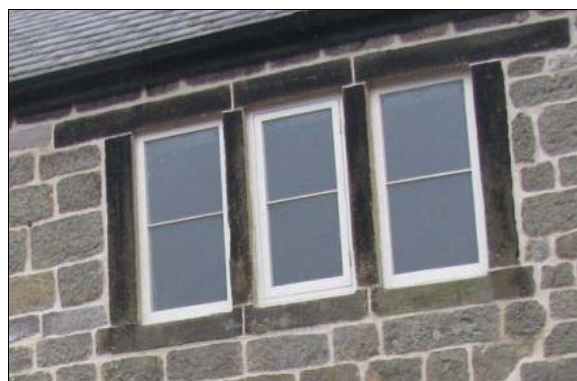
*P5.5 C18th window at Rose / Joiners Cottages*

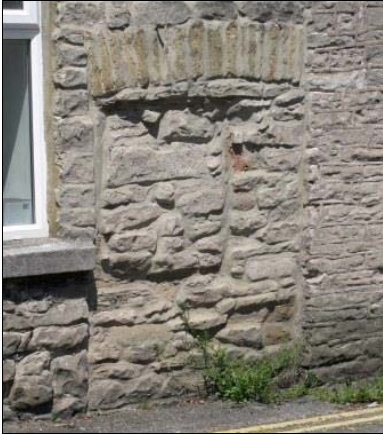
**5.14** Blocked or reduced openings on some buildings in the Conservation Area indicate earlier origins. For example, 1 Bridge Street has a blocked segmental arched doorway facing Bridge Street, which is at a low level, indicating that the ground level has been raised; the arch

could signify that this was originally an outbuilding.

*P5.6 Blocked doorway to 1 Bridge Street*

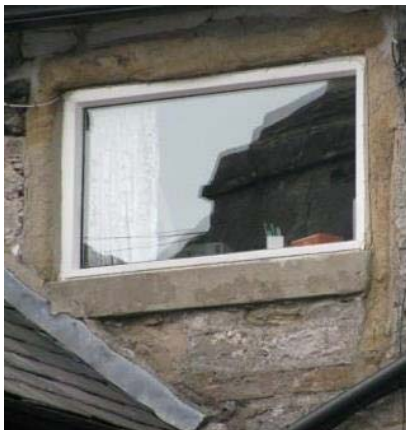
**5.15** Blocked openings at 1 Towngate, suggest that the forward-projecting wing may post-date the original building. The quoins to the left-hand side of an earlier blocked doorway appear to be hidden behind the adjoining wall of the projection. The second floor window was originally larger, as the original sill and lower part of the right-hand jamb can still be seen in the stonework beneath a newer sill – the stonework to the bottom left-hand corner of the original window must also be behind the projecting wing.

*P5.7 Earlier window opening to 1 Towngate*

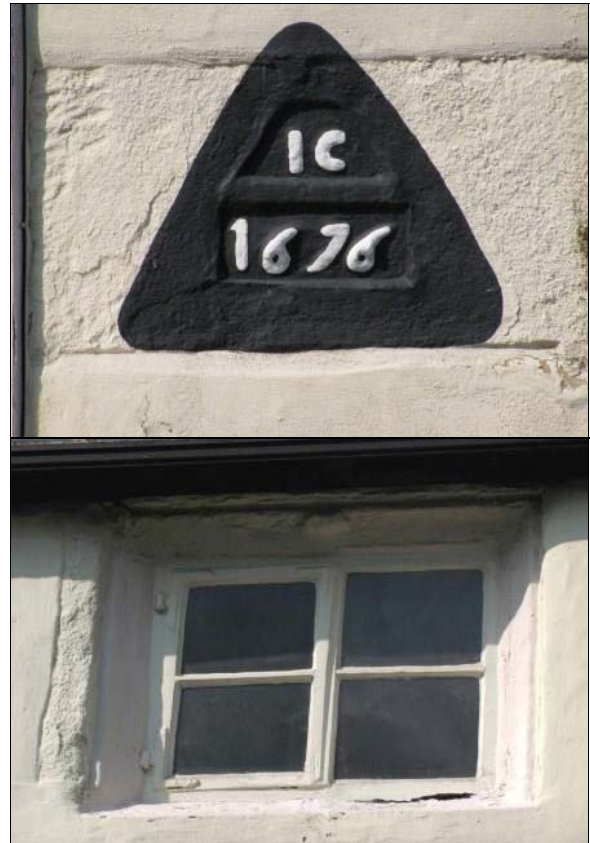
*P5.8 C17th datestone & window, White Hart Inn*

retains a triangular datestone which reads 'IC 1676'. The large rectangular piece of stone on which the datestone is inscribed may originally have been the lintel for an entrance doorway, as it appears to retain the seatings for former door jambs at each end of its bottom edge. There are two recessed and double-chamfered seventeenth century window openings to the top storey at the front.

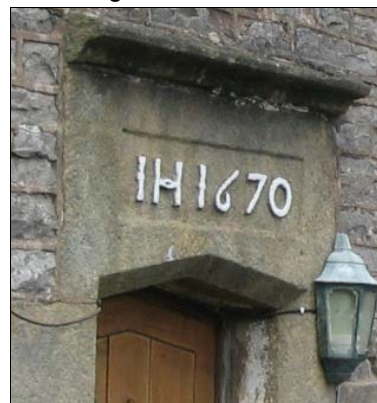
**5.19** Smalldale Hall has an inset panel on the door lintel inscribed 'IH 1670', and retains typical seventeenth century detailing, including a four-centred arched seventeenth century doorcase, with a hoodmould over and with chamfered, flush quoins. A number of double-chamfered window openings remain, some with hoodmoulds and some still retaining chamfered mullions. There is also an ovolo-moulded doorcase at the western end of the frontage, again contemporary with the age of the building.

*P5.9 C17th century detailing to Smalldale Hall*

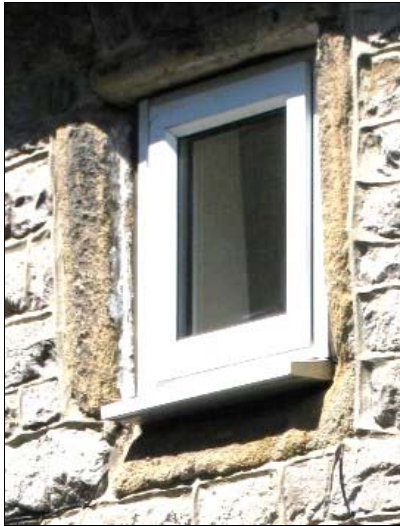
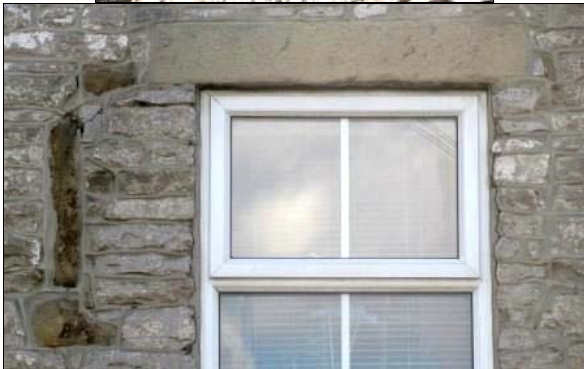
**5.20** A few other buildings in the Conservation Area show evidence of seventeenth century origins, although much altered since then. The Bread Shop, on Netherside, has a double-chamfered window to the first floor of its south-facing elevation. There is also part of the window surround to an altered earlier opening at first floor level above the shop window; a straight joint within the stonework to the right of the current window marks the original shape of the earlier opening, and its horizontal emphasis also suggests a seventeenth century date.

*P5.10 Earlier windows at the Bread Shop*

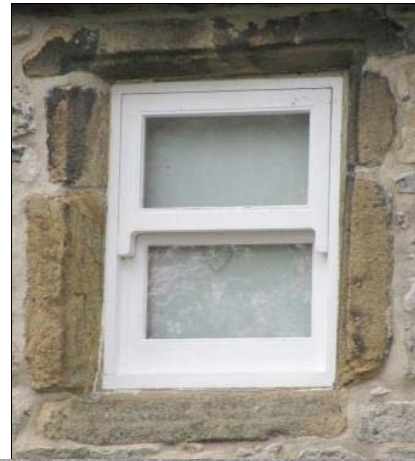
**5.21** Laburnum Cottage, at Hill Head, has a seventeenth century double-chamfered window opening to its south elevation at the rear and there is also an earlier lintel above a blocked door or window opening. Cheetham Cottage, at the junction of Netherside and Hugh Lane, has a double-chamfered window to its west-facing rear elevation on Hugh Lane, which may be seventeenth century; the stonework to most of the other window openings at the rear of the property is covered by heavy render, which may obscure further earlier details.

*P5.11 C17th windows, Laburnum Cottage (top) and Cheetham Cottage (bottom)*

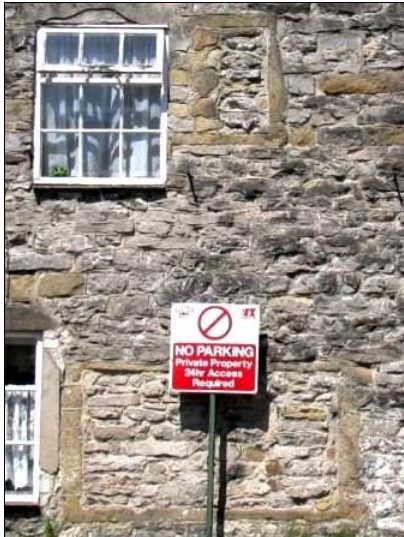
*P5.12 Blocked earlier windows on the south-facing gable of Bridge House*

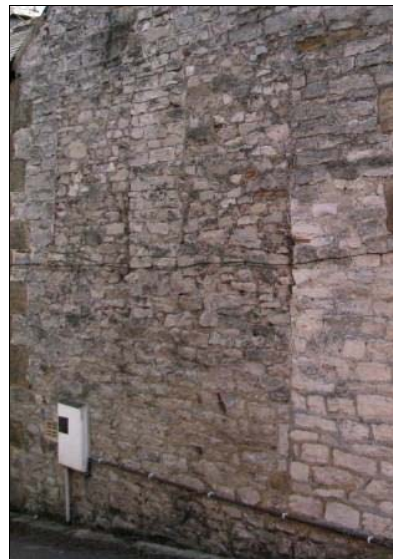
*P5.14 Blocked windows to Chapel House gable*

**5.28** Chapel House, on Fernbank, was originally built as the first Wesleyan Methodist preaching house in 1768. The windows and door surrounds to the front elevation appear to be contemporary with this date, and two tall, blocked windows can be detected at the gable end of the building, possibly originally chapel windows.

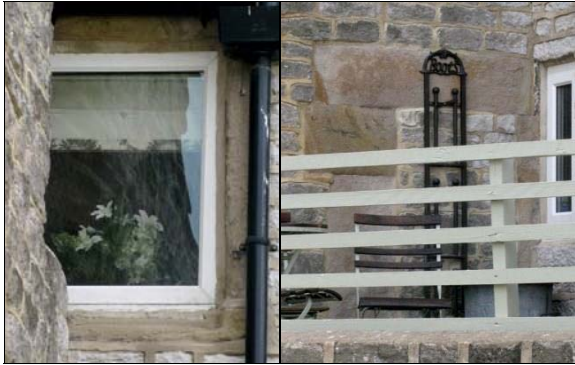
**5.29** Honeysuckle and Sydney Cottages (Grade II listed), on Hungry Lane, retain full eighteenth century door and window surrounds, with mullions, although an additional sill has been inserted into the ground floor window of Honeysuckle Cottage. Bank Cottage, to the rear, has an eighteenth, or possibly earlier, first floor window surround that is positioned partly behind the wall of Sydney Cottage, which curves round to accommodate it; the quoins and lintel to a blocked doorway on the north gable of Sydney

Cottage, however, are partially covered by the wall of Bank House. These buildings have undergone some rebuilding and it is difficult to determine, from current evidence, which building pre-dates which.

*P5.15 Partially covered window at Bank Cottage (left) & door surround at Sydney Cottage (right)*

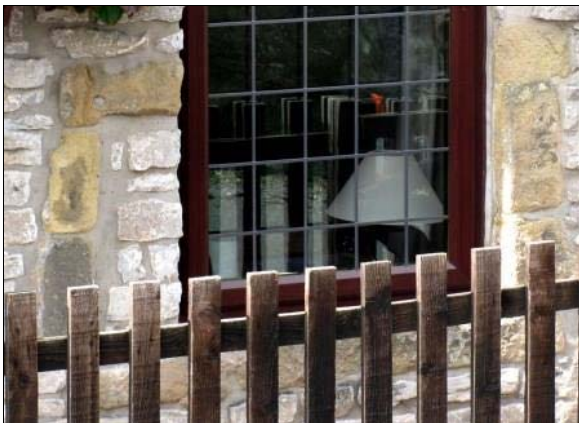
*P5.16 Altered earlier window to Peak Cottage*

**5.31** Peak Cottage, next door, still has an earlier gritstone lintel behind the porch and the remnants of an earlier, flush gritstone window surround on the ground floor, to the right of the doorway, with a more modern window opening superimposed upon it. The strong horizontal emphasis of this original opening could suggest an earlier, possibly seventeenth century date.

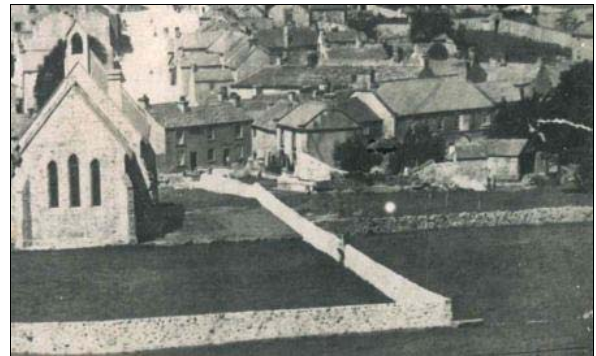
*P5.17 Earlier, lower roofs to 1 & 7 Church Street*

**5.35** 3 and 5 Church Street appear to have been constructed as a single building, pre-dating the properties to either side. The building has coped gables to each end, with stone gable stacks and moulded kneelers, which now project beyond the roofline of the adjacent properties. These features, together with the horizontal emphasis of the building, may suggest an eighteenth century build date. On the 1843 Tithe Plan, nos. 3 and 5 are identified as "House in ruins", while 1 Church Street is identified as "Outbuilding". Historic photographs show the roofs to both nos. 1 and 7 at a lower level than that to 3 and 5 (P5.17 below). No. 1 was demolished and rebuilt in the early twentieth century, presumably when the roof was raised and the shop-front added.

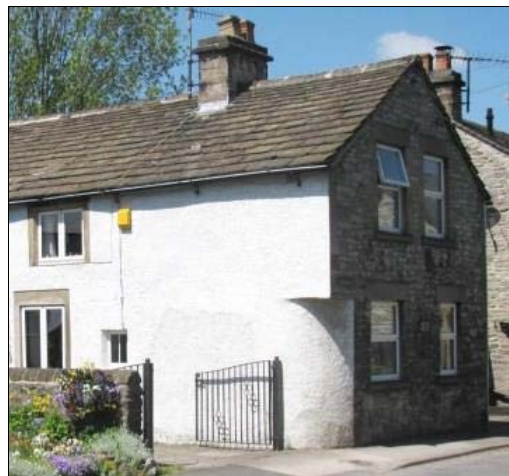
*P5.18 Rosleigh Cottage today*

**5.36** Rosleigh, on Church Street, the birthplace of Samuel Fox, retains an eighteenth century window to its south-facing elevation, although the sill has been covered with render. The front of the building has been raised in height (compare photo P3.11 with P5.18 below).

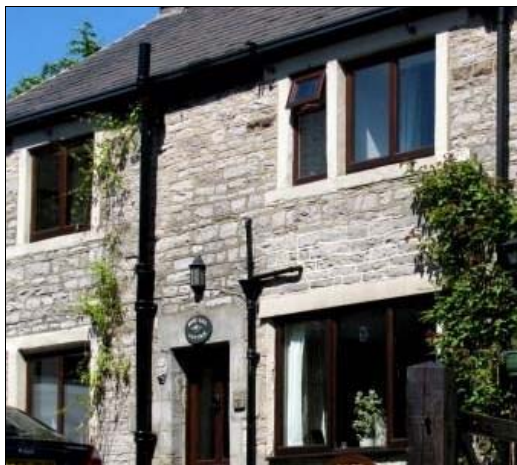
*P5.20 C18th windows to Rose Lea, Hugh Lane*

south elevation appear to date from the eighteenth century; the mullions have been removed.

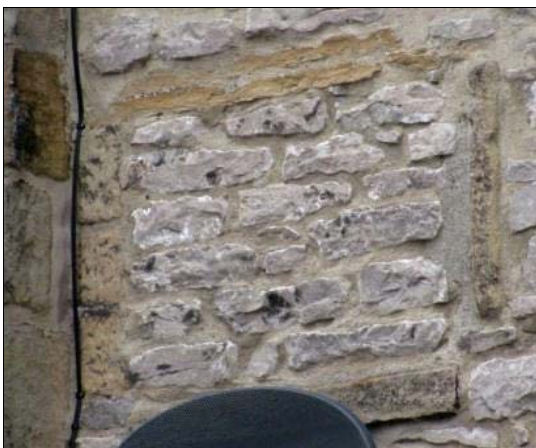
*P5.19 Blocked earlier opening to Edge View, Hugh Lane*

**5.38** Edge View was originally built as the barn to The Croft, and a blocked earlier opening to its south elevation may have been a pitching hole. The quoins to both Edge View and The Croft suggest an earlier date than the current window and door surrounds.

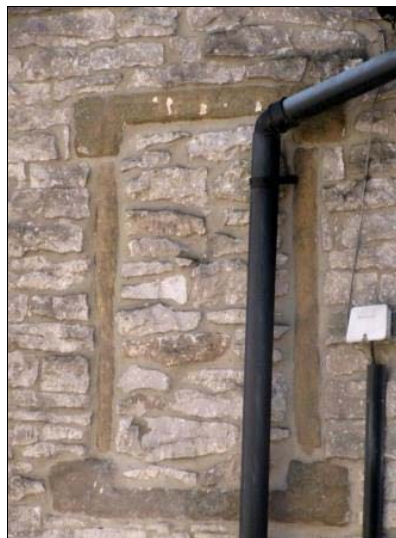
**5.39** Hartle Cottage has a blocked window opening to its north-west gable, which may be eighteenth or even seventeenth century. There is also a large, gritstone, former door lintel on the south-west elevation, just above a modern concrete window lintel.

*P5.21 Blocked C18th window to Hartle Cottage, Hugh Lane*

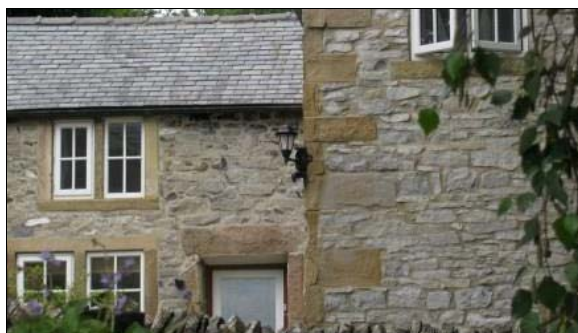
**5.41** In Smalldale, The Knoll has eighteenth century windows to its main north-east facing façade and an eighteenth century window to its north-west elevation. Holly Cottage also retains eighteenth century flush stone window and door surrounds to both front and rear elevations. There are also surviving eighteenth century window and door surrounds to the buildings at the eastern end of Smalldale (see the Architectural Development Map, Fig. 15).

*P5.22 C18th windows to The Knoll, Smalldale*

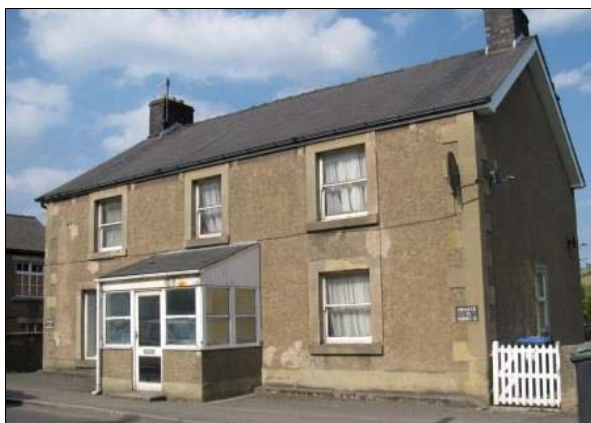
*P5.23 Newburgh House today*

**5.45** Newburgh House may also be contemporary with these former farm buildings (see 3.49). Photo P3.13 shows the building when it was the Newburgh Arms public house: it appears to have been rendered, with nineteenth-century window surrounds, but the render is smooth and painted and the quoins are flush with the render. The building had stone gable end stacks and moulded, gritstone corbels supporting the gutters. Since then the building has acquired a non-traditional front porch, deep overhanging eaves with white barge-boards, a fascia board rather than stone corbels to support the gutter and blue engineering brick chimney stacks have replaced the stone stacks. The ground floor window to the left of the entrance porch has been widened. A heavy, modern, pebble-dash render has been applied to both this building and the adjacent Club building, with applied, cemented projecting quoins.

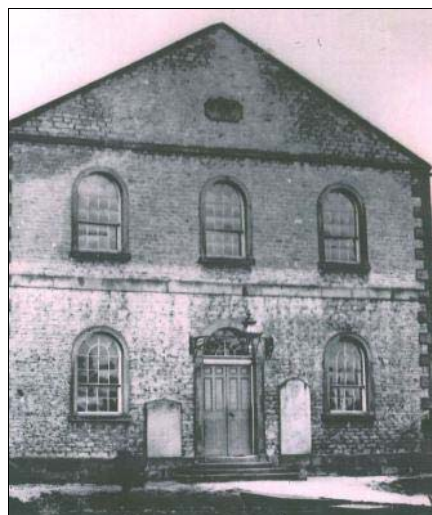
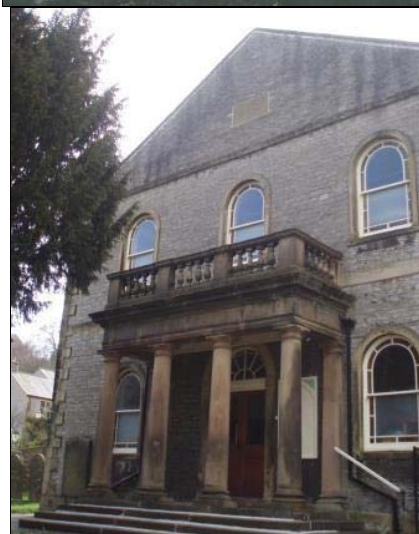
**5.47** Most of the religious buildings in Bradwell date from the late eighteenth and nineteenth centuries. The Methodist Chapel on Towngate was originally constructed in 1807, as the Wesleyan Chapel. The four-columned Tuscan stone portico with balustraded parapets was added over the central doorway in 1891, when the building was altered and refitted (Bradwell Historical Society, 2008). The frontage, above the portico, has a pedimented gable with a central plaque inscribed 'Wesleyan 1807. Restored 1891'. The building has rows of semi-circular headed margin light sash windows in raised surrounds, to both sides and the front. The sashes have coloured glass in the margins.

*P5.24 Methodist Chapel before 1891 and today*

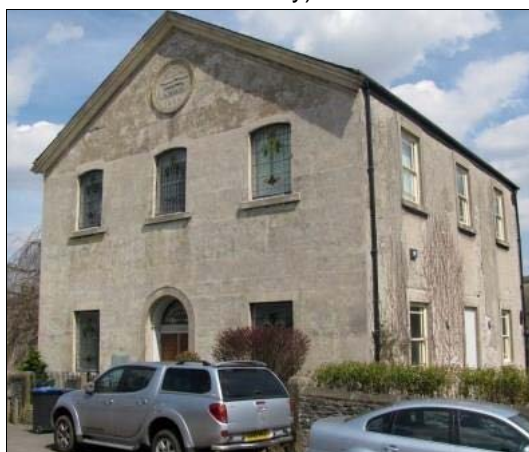
*P5.25 The Bethlehem Chapel today*

**5.48** The Bethlehem Chapel on Hugh Lane, built in 1845 and enlarged in 1878, is an important unlisted building within the Conservation Area, visible from many parts of the settlement. A circular stone plaque with a raised, moulded surround on the gabled frontage, records these dates but the original 1845 name in the centre of the plaque, which read 'Primitive Methodist Chapel', has been obscured. The building was renovated in 1914, with new windows and an entrance porch added (Bradwell Historical Society).

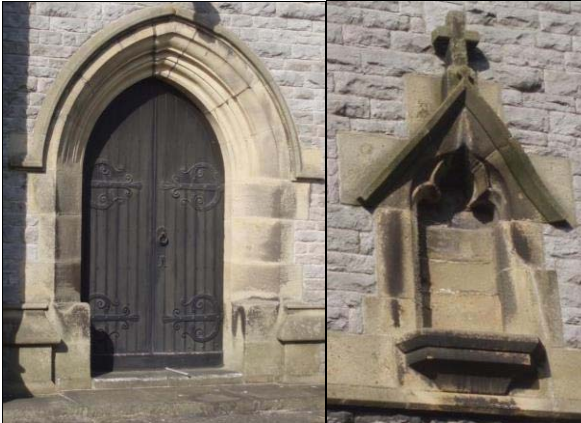
*P5.26 Gothic detailing to Church of St. Barnabas*

**5.49** The Church of St. Barnabas, constructed in 1867 by CC Townsend, has a stone plaque inscribed 'AD 1867 THS XP'. The tower was added in 1888-91. The building is a typical example of Victorian Gothic ecclesiastical architecture, with trefoil-headed lancet windows and quatrefoil windows, flowing tracery and a crown post roof internally.

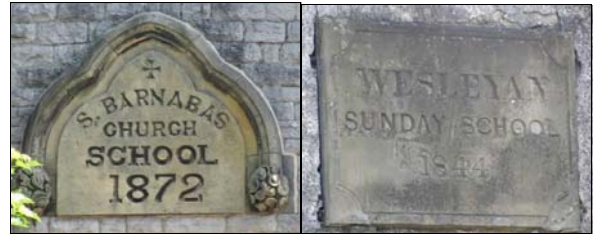
**5.51** A number of nineteenth century buildings have datestones, for example St. Barnabas School (1872) and the former Wesleyan Sunday School on Bridge Street (1844). Whiterock House on Church Street has a datestone of 1862 on its south-west gable end, but an earlier photograph shows that this end of the property

*P5.28 C19th datestones*

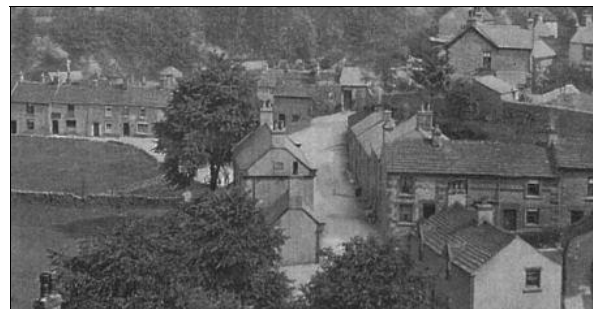
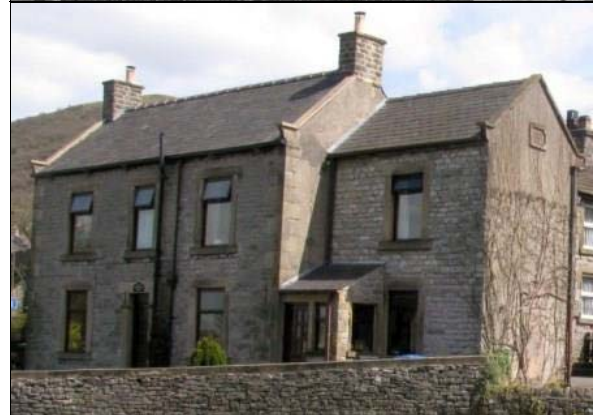
has been raised: the datestone was originally on the south-west gable of the main part of the building.

*P5.29 Whiterock House in the early C20th (centre of top photo) and today (bottom photo)*

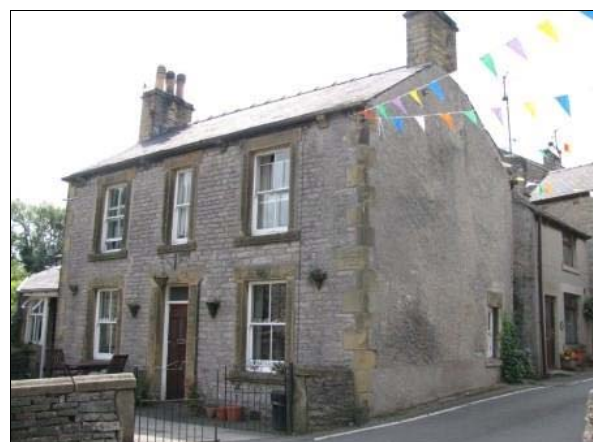
*P5.30 A typical late C19th symmetrical frontage at Eccles View, Smalldale*

**5.52** Later-nineteenth and early-twentieth century buildings have a more vertical emphasis and typically have symmetrical frontages, with a central doorway, sash windows on each side to each floor, and with gable end chimney stacks.

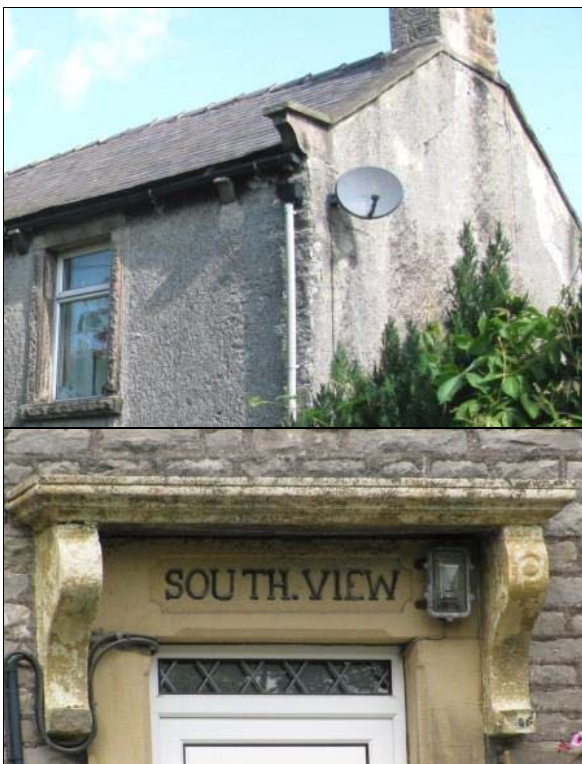
**5.53** Stone coped gables with moulded kneelers are also typical, for example Wortley House on New Church Street, Whiterock House

on The Hills and The Old Manse on Netherside. A few properties have a bracketed canopy above the central doorway, for example South View in Smalldale and Hill Stiles on The Hills.

*P5.31 Wortley House (top); South View (bottom)*

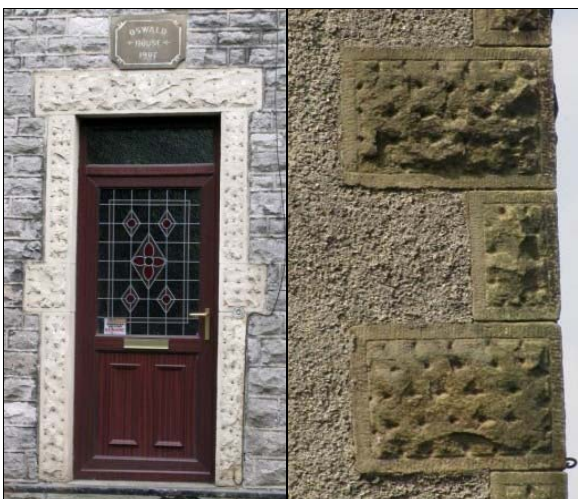
*P5.32 Pick tooled finish to dressing, Oswald House (left) and Heather Lee (right)*

**5.54** A pick tooled finish to gritstone dressings is a nineteenth/early-twentieth century detail commonly found in Bradwell, for example at Eccles View in Smalldale, Oswald House in The Hills and Heather Lee on Hungry Lane. A few late-nineteenth/early-twentieth century properties have decorative fretwork to their gables, for example Hunters Green on The Hills.

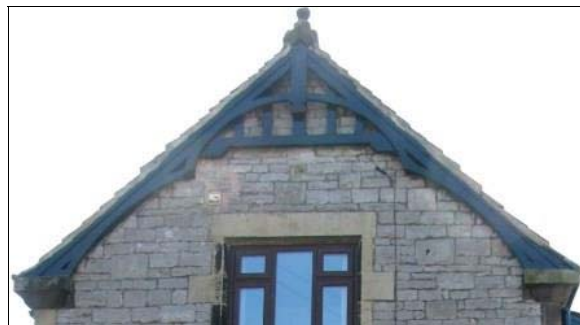
*P5.33 Decorative fretwork, Hunters Green*

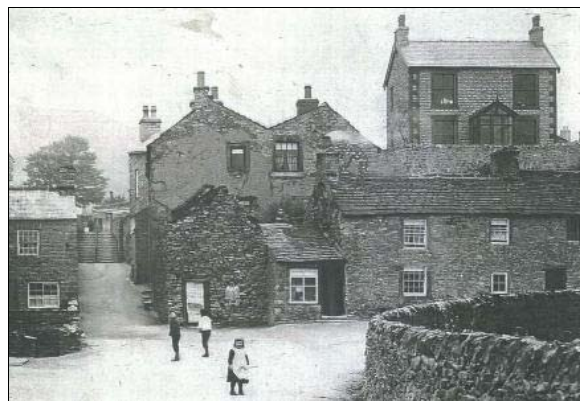
**5.55** A number of buildings have had twentieth century dormer and bay windows added to the original buildings. Early photographs show some of these buildings before the dormers were added, for example, Brook Buildings, Ashover House and The Manse on Brookside and Clematis Cottage on Church Street.

*P5.34 Clematis Cottage - no dormer windows*

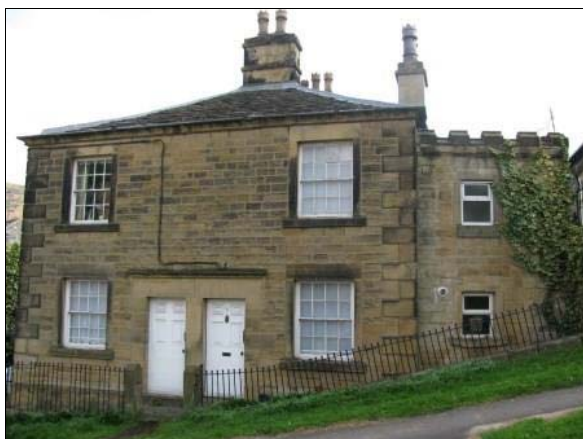
P5.35 Stanley House

**5.59** A number of buildings display individually distinctive architectural features. Stanley House (Grade II listed), on Towngate, has a hipped roof, which is an unusual feature for an early nineteenth century building in the Conservation Area. The building also retains its original, early-nineteenth century sash windows, with no horns

to the sashes and with smaller panes - horns were introduced when panes of glass increased in size from around 1860 onwards. Other distinctive features include a plinth and covered eaves cornice to the main part of the house, and castellated parapets to the western addition. The house was originally two separate houses and the two front doors still remain, with continuous moulded hoods and original panelled doors, although the bottom panels have been infilled.

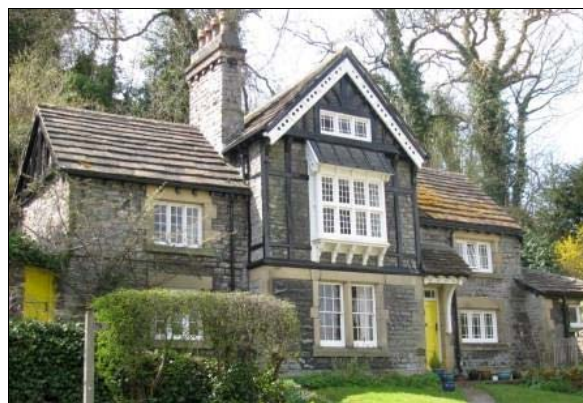
P5.36 Dale End Cottage

**5.60** Dale End Cottage, at Dale End, is an important unlisted building within Bradwell Conservation Area, combining decorative elements reminiscent of late-nineteenth century Arts and Crafts design, alongside alpine-style features, which echo some of the model estate houses in Ilam. Features of interest include, for example: the oriel window to the front elevation, with timber mullions and transoms and diamond lattice glazing to the side lights; projecting timber rafter feet and verges; and ornamental barge-boarded gables with half-timbered trellising and overhanging eaves. The oversized chimney and the oversized, elaborate brackets supporting the open porch are typical features of Arts and Crafts design. The Swiss-cottage style is atypical in the Peak District, with the exception of Ilam. It is likely that the present house is a rebuilding of an earlier, more humble cottage, or row of cottages, as the stonework to the front gabled projection appears to be of higher status than that to the walling to either side: photo P5.37 below shows the original row of cottages in this location, as well as the original form of The Sett, to the north.

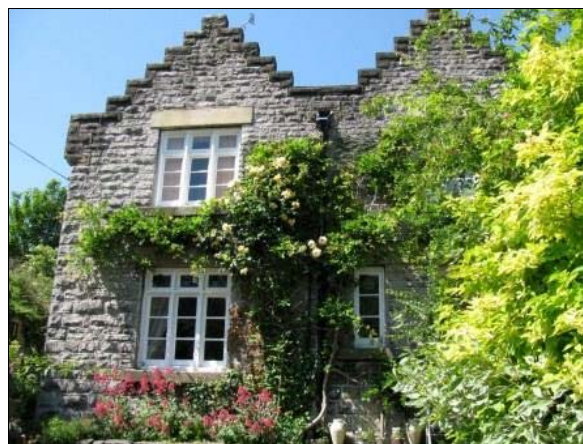
P5.38 Corblestones

**5.61** Corblestones, on The Hills, has crows-foot gables to its west elevation, as well as timber mullioned and transomed windows.

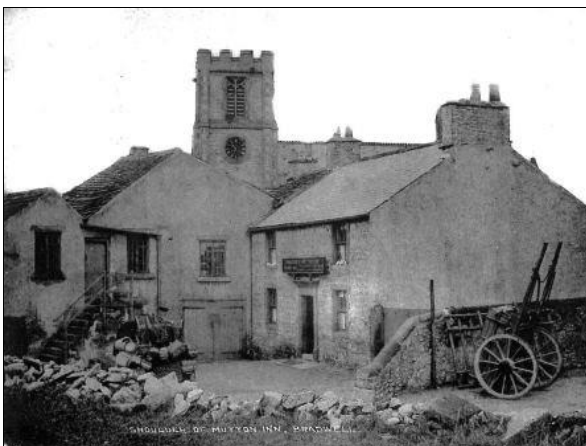
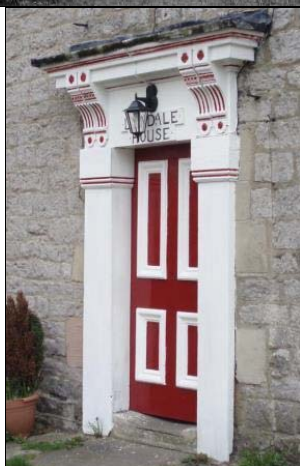
**5.63** Lyndale House (Grade II listed) has an elaborate central doorcase with a double bracketed, moulded hood above (see P5.39 below, bottom photo). The earlier photograph of the property (P5.39 top photo), however, shows that this has been superimposed on a more traditional, flush, gritstone quoined door surround, with a gritstone canopy over. On the earlier photograph, the house and attached

workshop have more traditional windows than now, with more subdivision, and the external stairs have a dilapidated stone base (rather than brick, as now) with possibly an arch beneath.

*P5.39 Original door surround and windows at Lyndale House (top); doorcase today (bottom)*

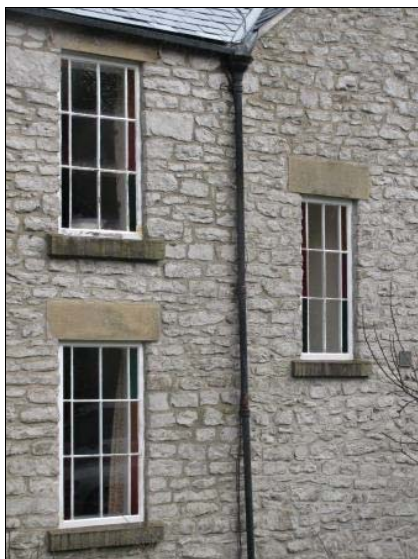
*P5.40 Margin panes to windows, Granby House*

**5.64** Granby House, in Smalldale, still retains mid-late Victorian windows with margin panes.

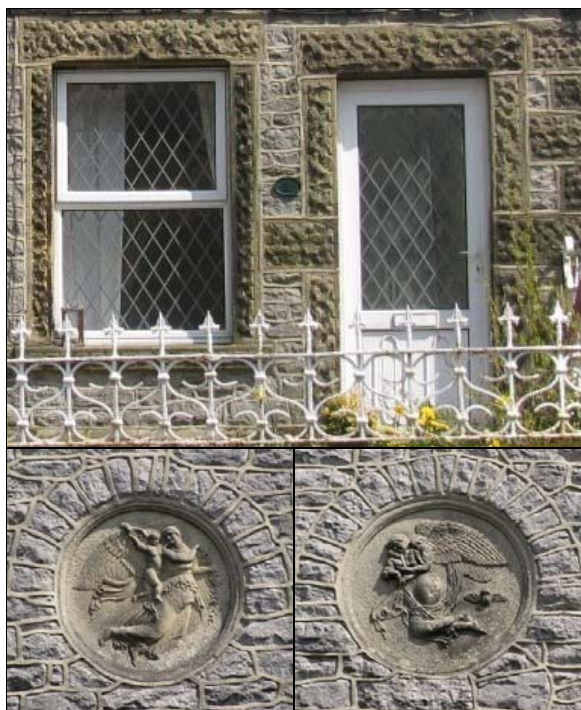
*P5.41 2 & 4 Fern Bank*

**5.65** Elaborate, carved stone plaques on 2 and 4 Fernbank are copies of bas-relief plaques in the Sculpture Gallery at Chatsworth, by the Danish sculptor Bertel Thorwaldsen (1770-1844) and represent Night and Morning. This building also has a pronounced pick tooled finish to all of the gritstone dressings, and the lintels above the door and windows have a decorative ogee-style central feature to their lower edge.

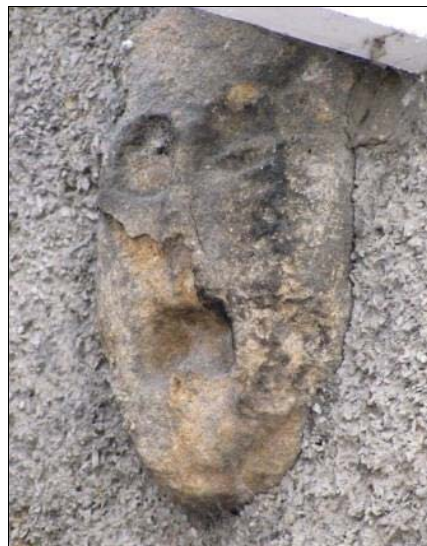
**5.66** No. 5 Church Street has a stone carved Green Man on the wall at the rear of the property. This was, apparently, originally located at the front of this building.

*P5.42 Stone Green Man, 5 Church Street*

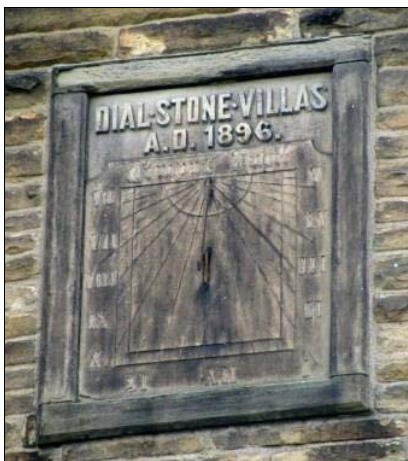
*P5.43 Dialstone Villas*

**5.68** Dialstone Villas on Hill Head has a gritstone plaque inset into the north-east facing

gable wall, with a dialstone inscribed with 'Dial Stone Villas A.D. 1896'. This is an important unlisted building in the Conservation Area.

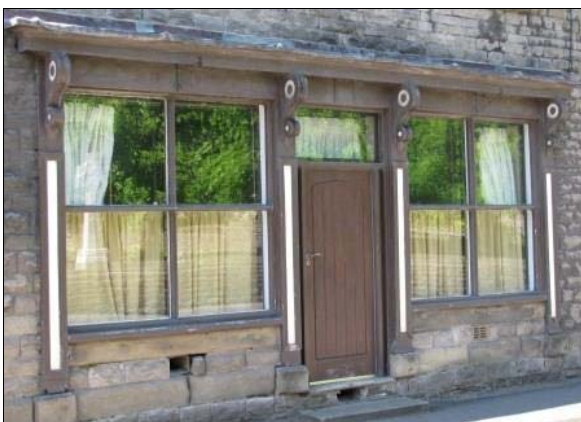
**5.70** A few existing and former shop fronts still retain many of their original decorative features, including Round the Back and the Doctor's Surgery. The former chip shop attached to the west end of Wortley House, still retains console brackets and a timber fascia with a cornice above.

*P5.44 Original shop front to Round the Back*

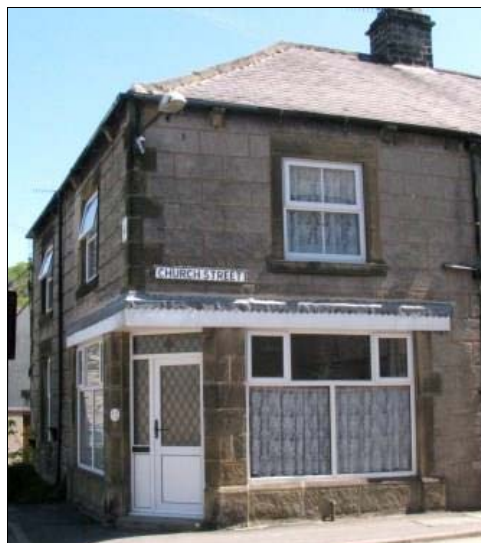
**5.71** A number of shop fronts in Bradwell had plain gritstone stallrisers and pilasters, such as 1 Church Street and High Peak Building (High Peak Heating Supplies) on Towngate. Other shops just had enlarged windows, rather than full

*P5.45 Former shop front, 1 Church Street*

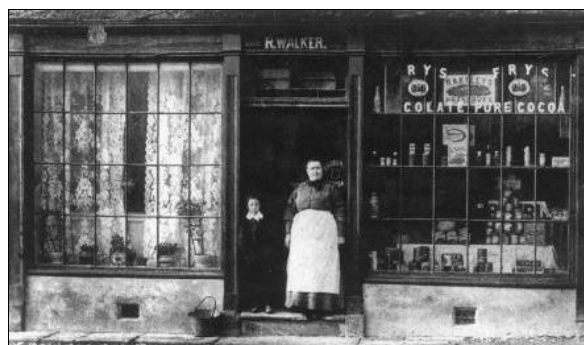
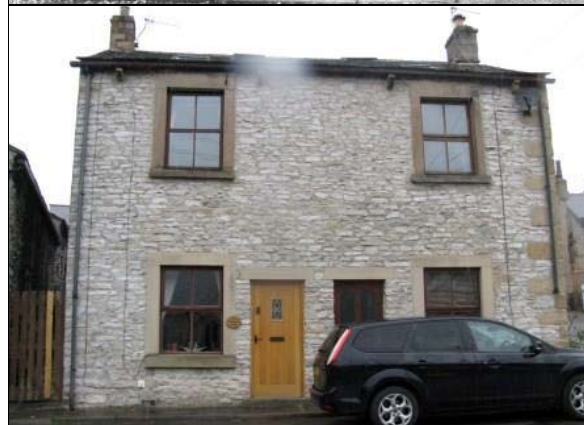
**5.72** Other former shops have now been altered so that all evidence of their former use has been removed. Photo P5.46 (top) shows an early, multipaned shop front to 1 and 2 Towngate Cottages, on Brookside. A later shop front had larger panes to the windows. The building has now been converted to residential use, and all evidence of its former use has been removed.

*P5.46 Original shop front to 1 & 2 Towngate Cottages (top) and the cottages today (bottom)*

**5.69** Many properties within Bradwell were formerly shops and although only a few shops still remain, a number of buildings retain former shop frontages. The first shop frontages developed in the eighteenth century, but the remaining shop fronts in Bradwell mostly date from the later nineteenth and twentieth centuries. Traditional shop fronts typically included a stall-riser beneath a raised window, or windows, with pilasters, console brackets, a fascia with the shop name and a central or off-set doorway, with a fanlight above. Earlier windows were multipaned (see photo 5.46 top); these were replaced with larger expanses of glass as this became available in larger sheets.

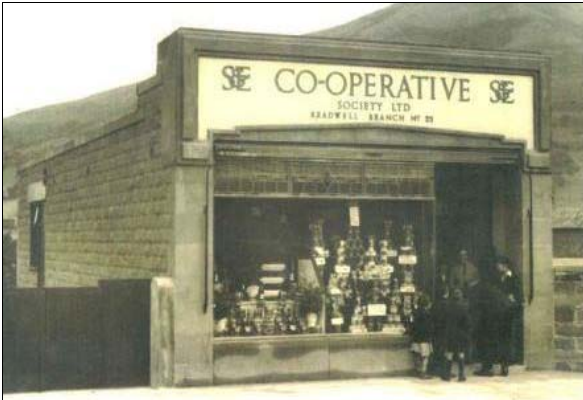
**5.73** The original Co-operative building, constructed in 1934, was flat roofed with Art

Deco touches. Alteration and extension in the later 1990s have obliterated its original appearance (Bradwell Historical Society, 2008).

*P5.47 Original Art Deco-style Co-operative store*

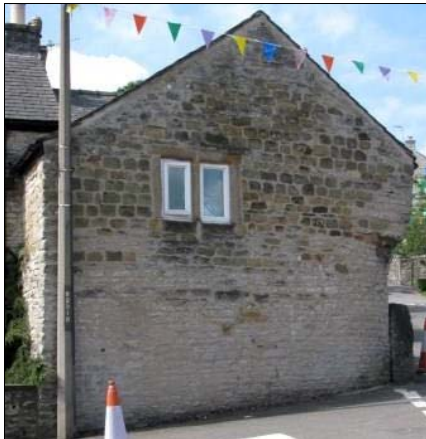
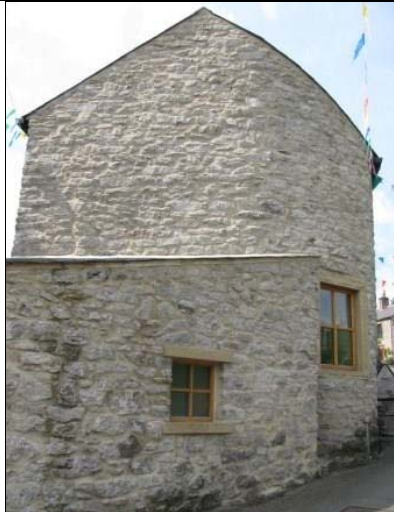
**5.74** Some buildings within the Conservation Area have curved corners to one of the walls. In some cases the curve follows a bend in the road, such as By the Way, Micklow View and the north-east corner of 1 Town Lane, in Smalldale, Clinton and Hunters Green Cottage on The Hills and the Bradwell's Ice-Cream shop. In other cases, such as at Tanfield Cottage on Church Street, the curve may have been intended to allow easier passage around the building, possibly to stables or other agricultural buildings.

*P5.48 Curved corners to 1 Town Lane and Micklow View, Smalldale*

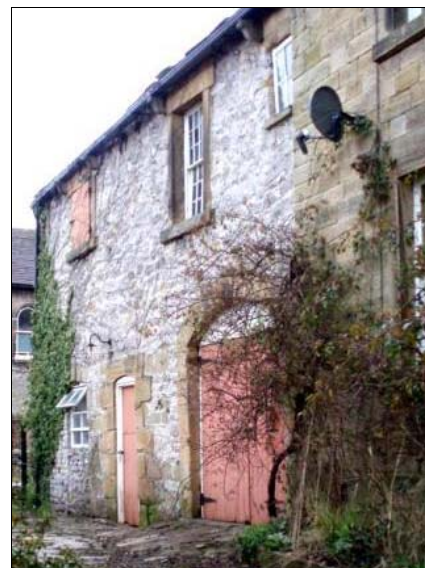
*P5.49 Stanley House stableblock*

**5.78** Although most of the original barns, workshops and other outbuildings within the Conservation Area have now been converted for residential or commercial use, a few still remain unconverted, retaining original features. For example, the attached stableblock to the rear of Stanley House retains a segmental headed archway, with internal stabling features still in situ on the ground floor. The workshop on Soft Water Lane, occupied by P. Austin Electrical, still retains an external flight of steps to allow access to the upper floor. External flights of steps still remain elsewhere in the Conservation Area, such as on the south-east gable of Newburgh Hall and the south-east gable of Ivy House, on Towngate.

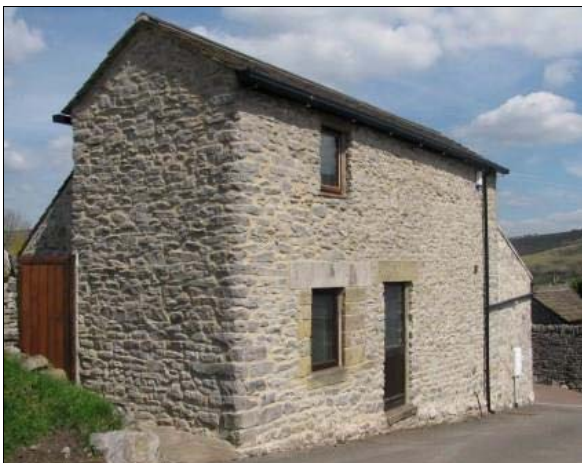
*P5.50 The Old Cobblers Shop, Charlotte Lane*

**5.79** The Old Cobblers Shop, at the east end of Charlotte Lane, has tall, narrow proportions,

typical of a workshop building. The building has now been converted to domestic use and the chimney stacks have been removed from the west gable.

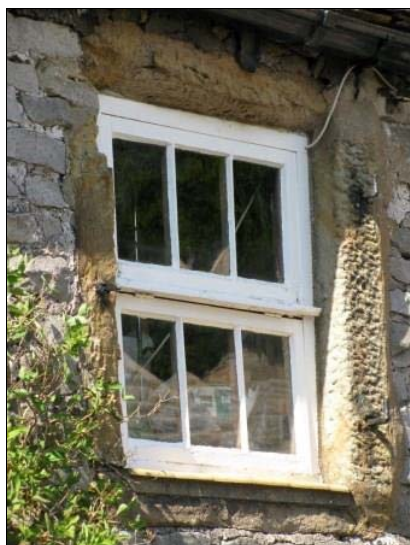
*P5.51 Iron pintles & latch at Ford Cottage*

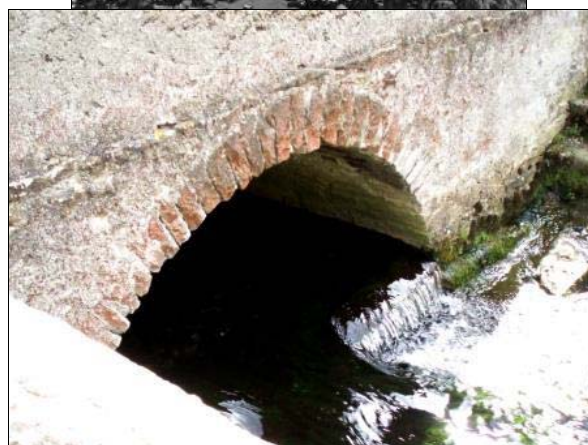
*P5.52 Road bridge still with its segmental arch (top); brick arch beneath Brook House (bottom)*

**5.50** Brook House, built in 1826, is constructed over the Bradwell Brook, which runs directly under it through a segmental arched tunnel. There are tall, pointed-arched windows, with early-nineteenth century Gothic Y-tracery in the upper sections and small paned windows below, to both floors on the east elevation and to the upper floor of the west elevation. Those to the latter have Gothic hood moulds above each window. An early photograph from the 1840s shows that the building originally had four identical windows to the ground floor of the west elevation, but these had been replaced by 1911, with two large square windows and a central door. The building now has four square windows to the ground floor.

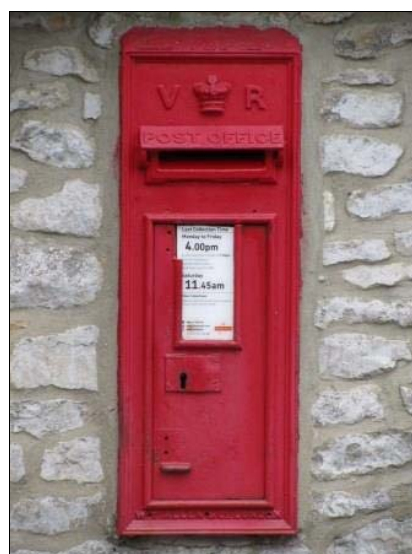
*P5.53 Victorian pillar box on The Hills*

**5.83** There is a Victorian pillar box at the top of the steps leading from Church Street up to The Hills. A K6 red telephone box, designed by Sir Giles Gilbert Scott and introduced in 1936, stands near the footbridge on Towngate.

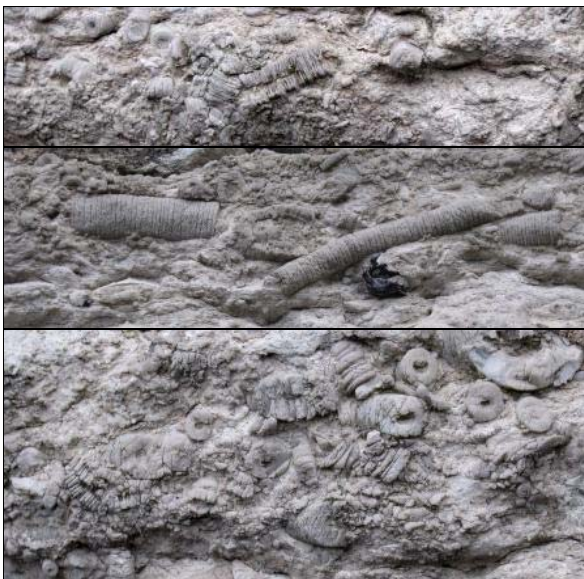
P6.1 Fossils in the limestone wall of Stonecrop Cottage, Far Hill

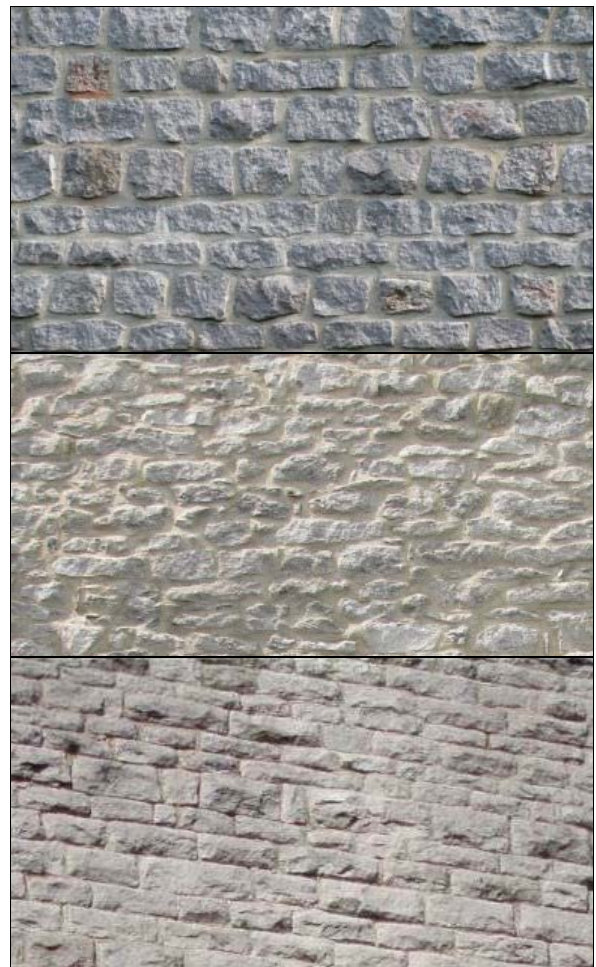
P6.2 Coursed, squared limestone (top); rubble limestone brought to courses (middle); rock-faced finish (bottom)

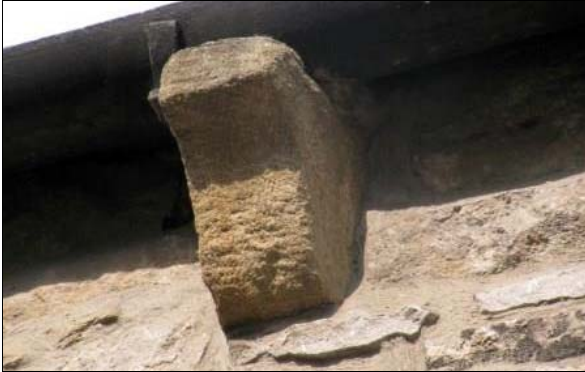
P6.3 Moulded gritstone corbel supporting gutter

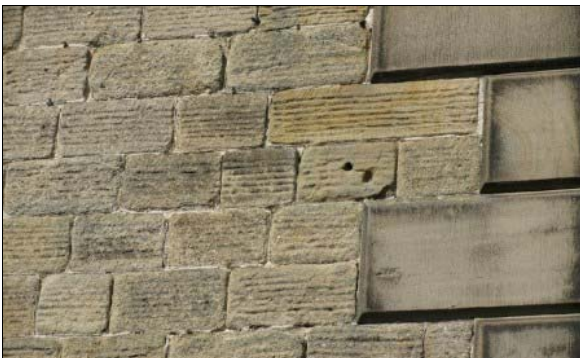
P6.4 Gritstone walls and quoins, Stanley House

**6.9** A few properties are constructed entirely from dressed gritstone, for example Stanley House on Towngate (Grade II listed) and Dialstone Villas on Hill Head. The frontages of Rose Cottage and Joiners Cottage on Towngate (both Grade II listed) are of coursed, squared gritstone with horizontal bands of limestone. The limestone walls of the Church of St. Barnabas have flush bands of gritstone. Tyrone Cottage, on Church Street, has a coursed, squared gritstone frontage, with limestone to sides and rear: early photographs show that the ridge of this building was raised at some point (see photo P5.17), and it is possible that it was re-fronted at the same time.

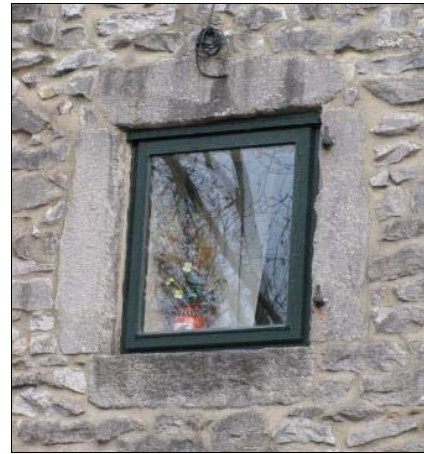
P6.5 Possible limestone window surround to mill building

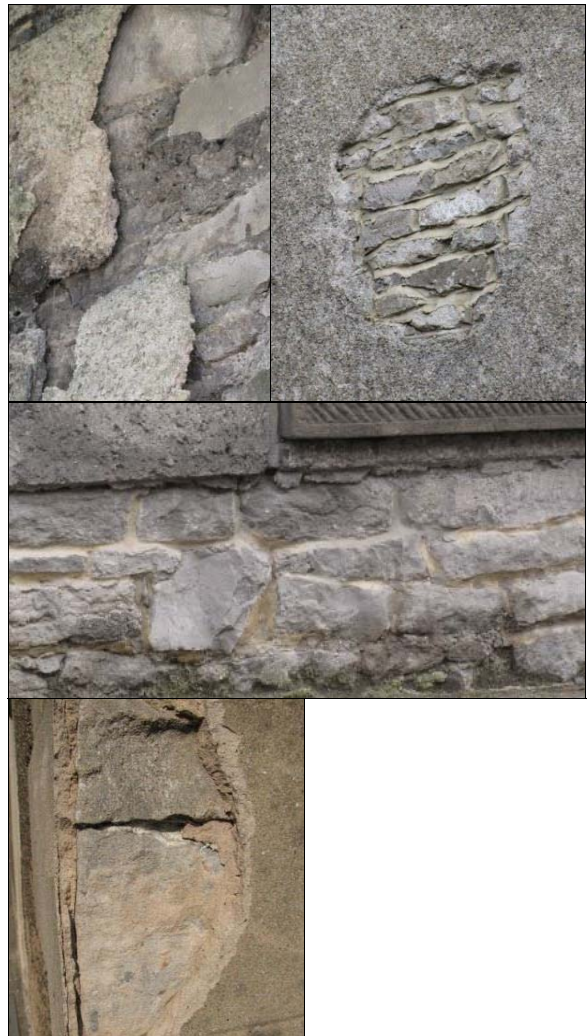
P6.6 Patches of render & cladding deteriorating to reveal stonework: Kinder Cottage, The Hills (top left); Bethlehem Chapel (top right); Bank House, Church Street (middle); Newburgh Hall (bottom)

**6.11** Many properties in Bradwell Conservation Area are covered with a modern cement render. A number of other buildings are covered with an imitation, squared-gritstone cladding. Where patches of render or cladding are deteriorating, the original limestone walls and stone dressings can be seen beneath.

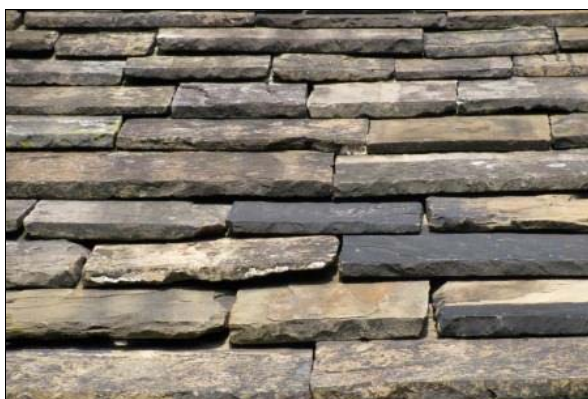
*P6.7 Stone slate roof*
