## 4.0 FORMER AND CURRENT USES

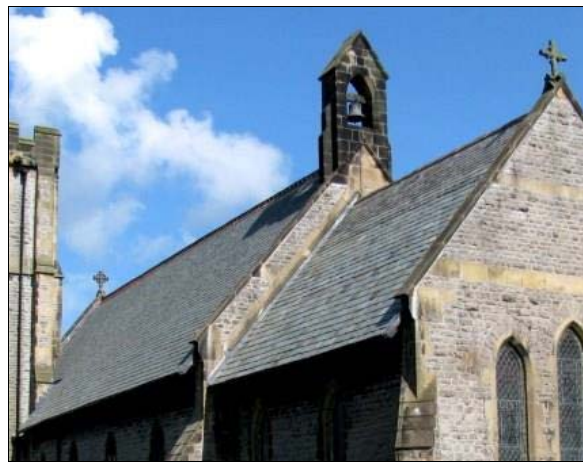
*P6.8 Church of St. Barnabas roof - Westmorland slate*

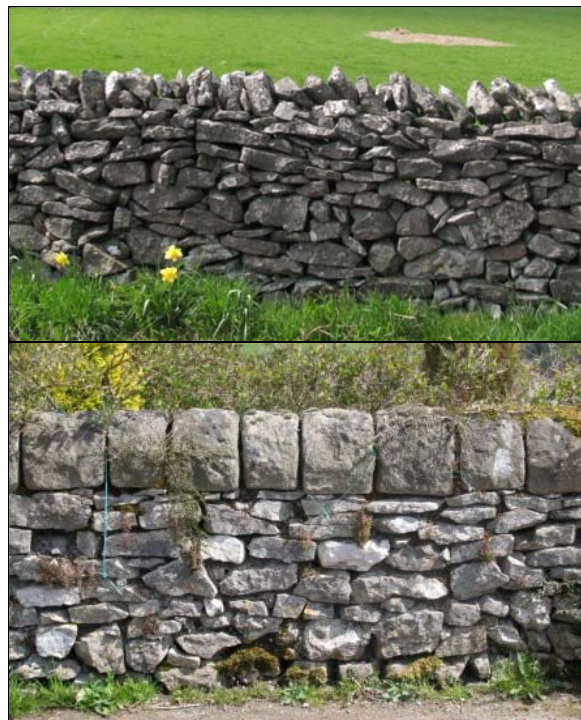
*P6.10 Drystone boundary walls, Granby Road*

**6.25** Land surrounding Bradwell is enclosed and therefore boundary walls contribute significantly to the character of the Conservation Area. Traditional dry-stone walls, found within the Conservation Area and its wider setting, often form field boundaries and define road edges. These limestone walls are tapered towards the top of the structure, whilst larger pieces of stone, known as through or bonding stones, tie the stonework together. Other boundary walls within the Conservation Area are of coursed, roughly coursed or un-coursed (random) rubble limestone construction, both dry-stone and mortared, or are of coursed, roughly squared limestone. There are a variety of both limestone and gritstone coping stone details, including tightly packed stones on end and dressed half round, hogback or saddleback copings.

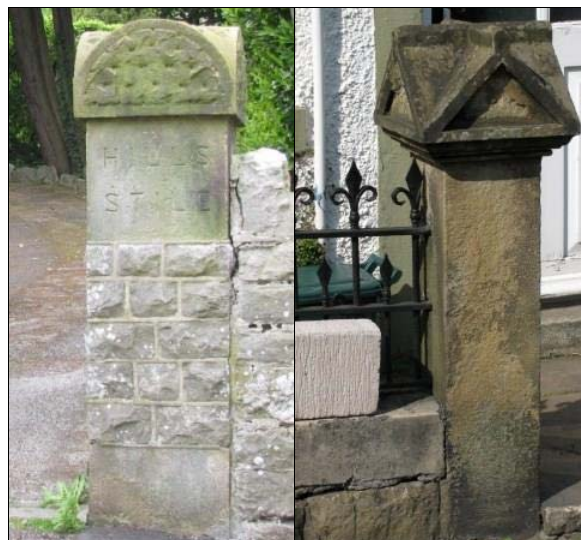
*P6.11 Gate piers to Hill Stiles, The Hills (left) and Cranberry Cottage, Towngate (right)*

**6.26** Various types of gateposts and piers punctuate the stone walls. These range from irregular, roughly dressed pillars with round or flat tops, broached piers and dressed gritstone piers with pyramidal or ball finials. Some of the early twentieth century villas on The Hills have decorative, pick-tooled gate piers, such as Oswald House. The gate piers to Hill Stiles are of limestone, with large gritstone blocks above and decorative, moulded, pick-tooled cappings.

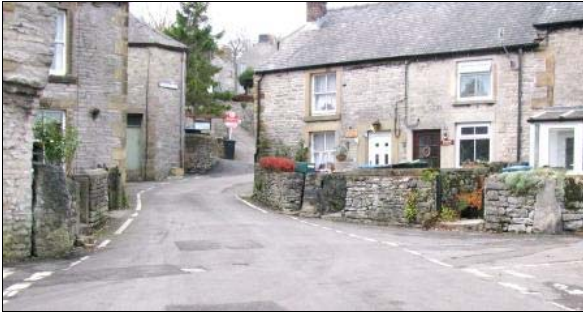
*P6.12 Gritstone posts at entrance to Smalldale*

**6.27** There is a large gritstone post on the south side of the road at the corner entrance to Smalldale from Gore Lane, and a corresponding post on the opposite corner of the entrance, incorporated into the boundary wall of Corner Cottage.

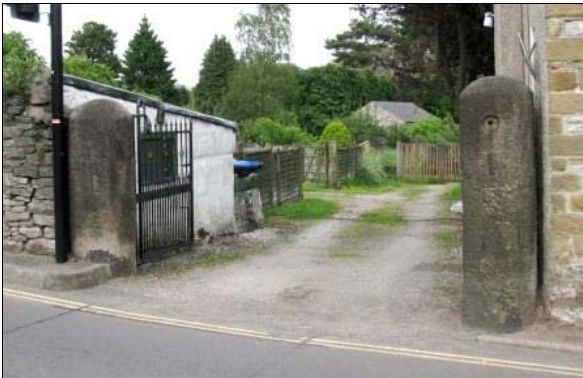
*P6.13 Turnpike gateposts beside Bridge House, Netherside*

**6.28** There are two large, columnar gritstone gateposts at the north side of Bridge House on Netherside, thought to be former turnpike gateposts, possibly from the Sheffield-Buxton turnpike (now the Hathersage-Castleton road).

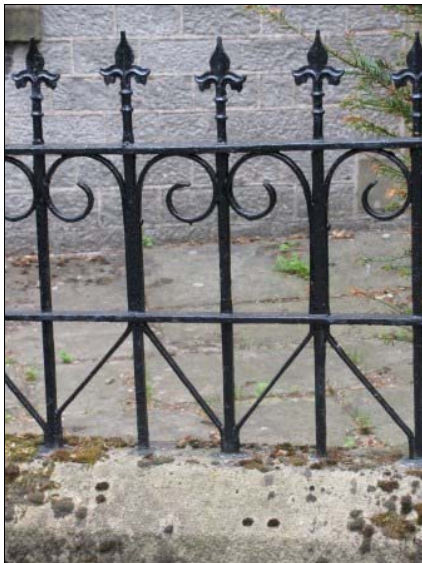
*P6.14 Traditional railings at Dale View, The Hills*

**6.29** Historic railings are formed from wrought and/or cast iron, embedded directly into coping stones, often above low, stone boundary walls, for example at Stanley House and the Wesleyan Sunday School on Towngate, and at Dale View on The Hills. A variety of finial designs can be found to the railings. Modern metal railings found in the town are generally thinner in section and the pales are not normally embedded into coping stones.

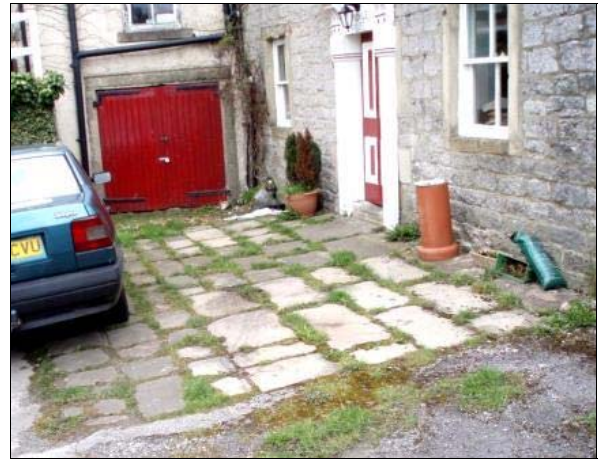
*P6.15 Limestone flags in front of Lyndale House*

**6.31** There are limestone flags in front of Lyndale House, which date from when the building was the Shoulder of Mutton public house. A flight of worn, wide stone steps leads up from Church Street to The Hills, with three large gritstone posts at the top: the steps have been turned over. There is a large gritstone threshold and gritstone kerbs, including a drainage channel, in front of the Old Bull's Head on Towngate and a set of worn gritstone steps on Towngate and a set of worn gritstone steps and a gritstone path lead up to the Old Post Office, remnants of the buildings' former uses. Stone flags or setts occur in small areas fronting other individual properties.

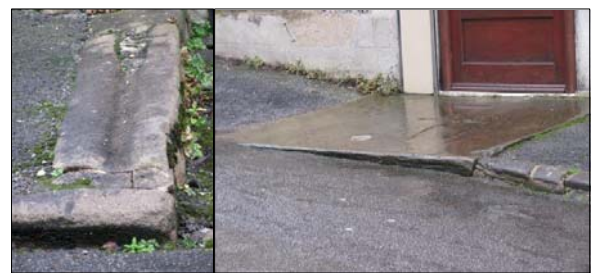
*P6.17 Old Bull's Head: gritstone kerb with drainage channel, and gritstone threshold*

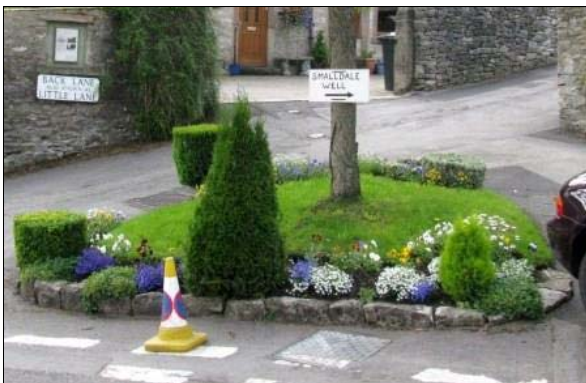
*P6.18 Gritstone kerb in Smalldale*
