WARSLOW'S FIELD BARN & FORGOTTEN FARMSTEADS

A self-guided trail exploring the
history of farming in the South West Peak

THE ANATOMY OF A FIELD BARN

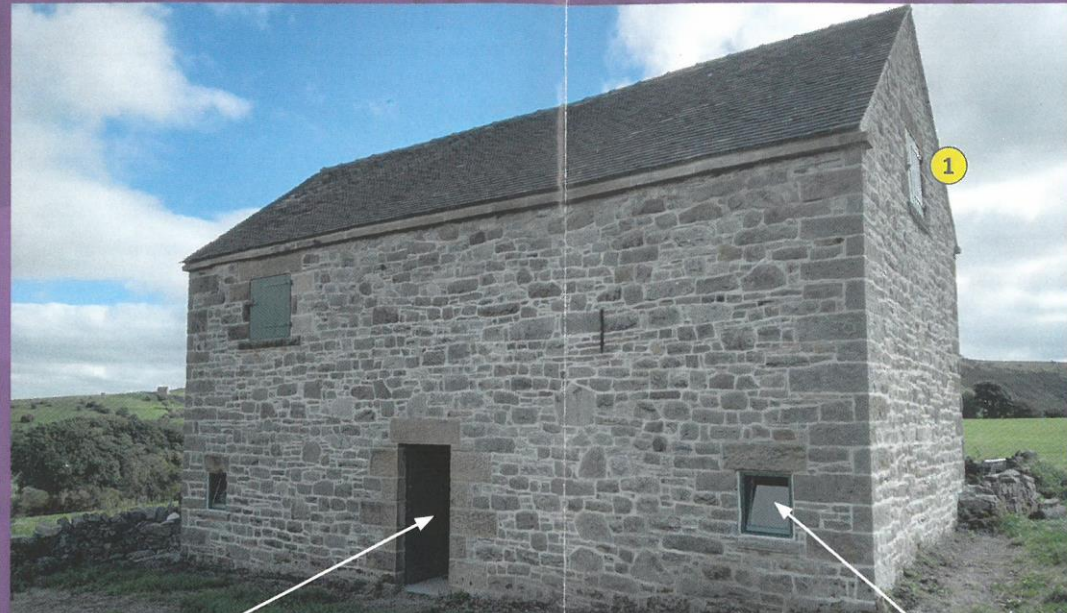
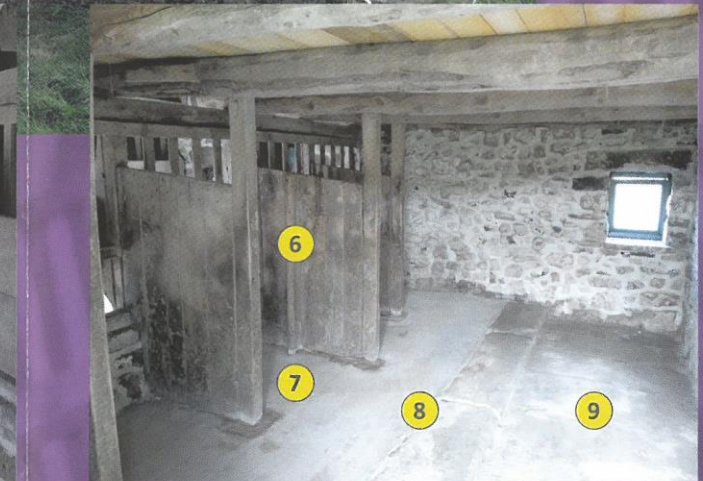
- 1 Pitching hole
- 2 Hayloft
- 3 Niche
- 4 Hay cratches
- 5 Fodderbing (central passage)

- 6 Ratch-stake (wooden post)
- 7 Boskin (stall)
- 8 Standing - raised area for boskins that cattle would stand on
- 9 Groop - lower area behind cows where muck would collect and be taken out the end door

B2 Littler's Barn - This is also known as Hobcroft Barn and was repaired by the South West Peak Landscape Partnership in 2021. It is safe to look inside. See the diagram over the page. It has many original features: boskins for cattle, a fodderbing with hay cratches, and even an old horse drawn sledge. Please close the barn doors and yard gate as you leave.
